Manhole Inspection Summary

Manhole # S33C__042MH

Insp Date: 7/31/08 2:28 PM

Location Address: **19 cathedral st**

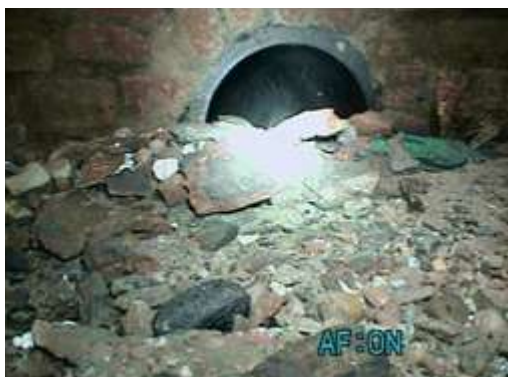
Defect 3

Condition: ☐ Sound ☐ Cracked ☐ Root Intrusion ☐ Deteriorated ☐ Leaks ☒ **Debris**

channel debris

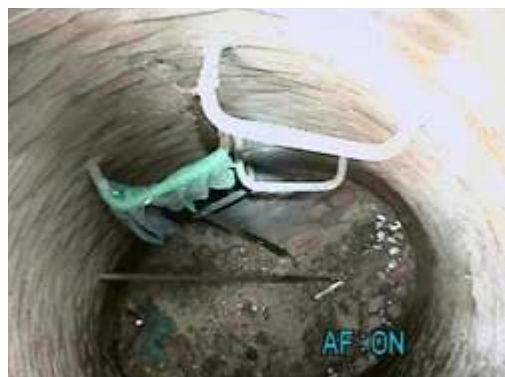
Defect 2

Count: **5** Missing: **0** ☒ **Corroded**

☒ **Evidence Of Surcharge** Depth: **4** (ft.) ☐ Active Surcharge Present

corroded steps and surcharge evidence

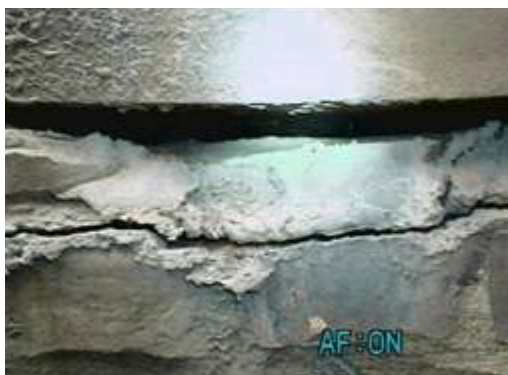
Defect 1

Condition: ☐ Sound ☒ **Cracked** ☐ Root Intrusion ☐ Loose Brick ☒ **Deteriorated**

cracked, deteriorated, frame adj
